THE FALL OF A HISTORICAL STRUCTURE

1914 Nueces County Courthouse, Corpus Christi,

By: Eric A. Trejo, P.E., SECB and Jennifer Scheffler, E.I.T.,LNV, Inc.

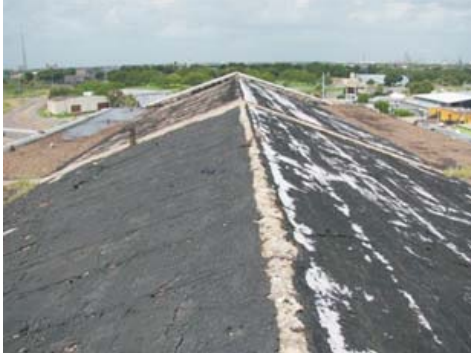
The roofing material is in very poor condition and the concrete roof slab is completely exposed in several places. Exposure of the concrete roof deck allows moisture to penetrate through the concrete and cause corrosion in the reinforcing steel, which as mentioned above, causes spalling of the concrete. In several locations on both the 3rd and 5th floor roofs, corroded reinforcing steel is visible at concrete beams and roof slabs.

Image 6. Current Roof Condition

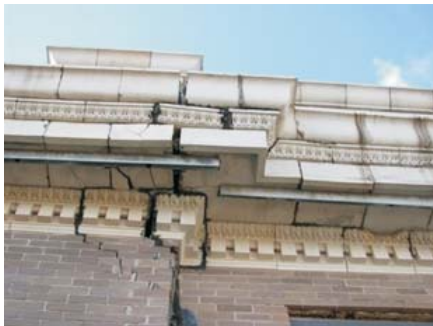
from the brick face appear to be held in place by mortar alone. Many elements are cracked, displaced, or missing due to corroded anchorage to the building. Some areas have been previously repaired with temporary bracing to prevent further detachment of terra cotta elements.

Image 7. Temporary reinforcing previously added at displaced terra cotta

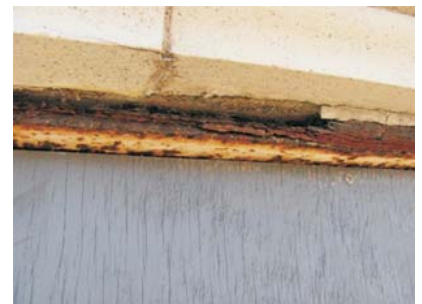
Much of what appears to be the original mortar has severe erosion. The veneer also has separations and cracks in several areas as the result of the differential foundation movement previously mentioned. The steel lintels supporting the veneer over the windows appear to be corroded resulting in additional vertical displacement plus the movement already occurring in the structure. The additional vertical displacement of the lintel is a result of section reduction due to the corrosion.

Image 8. Severely corroded lintel
