THE FALL OF A HISTORICAL STRUCTURE

1914 Nueces County Courthouse, Corpus Christi,

By: Eric A. Trejo, P.E., SECB and Jennifer Scheffler, E.I.T.,LNV, Inc.

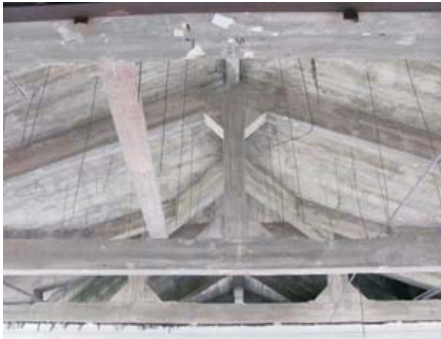
Image 3. 1914 Roof Framing

The roof system of the 1914 courthouse consists of cast-in-place concrete trusses with solid one-way slab systems spanning between these concrete trusses at both the third and fifth floor roofs, as seen in the photograph below. The only exception occurs at the flat portion of roof over the fifth floor, which is framed similarly to the fourth and fifth floors with solid one-way slab systems spanning between concrete beams.

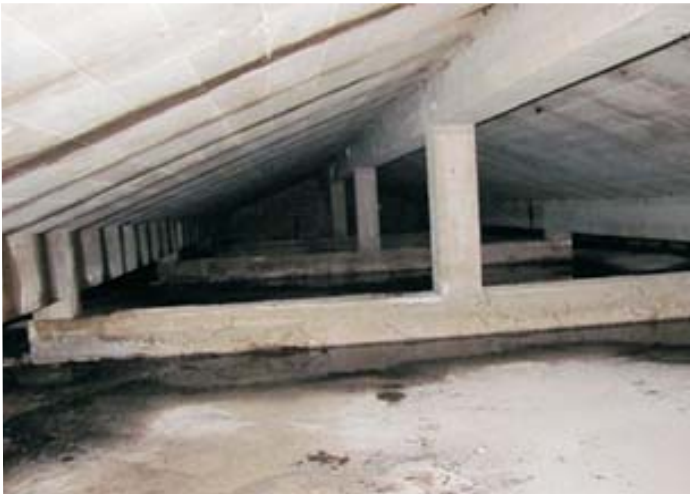
Image 4. 1930 Roof Framing

The roof system of the 1930 addition appears to have been constructed in two phases. In the first phase, the roof framing formed the flat ceiling followed by the second phase of the additional concrete beams with one-way slab systems which form the gable portion of roof, (see image 4).
